Engineering Change Notice (ECN) 001

LM-334 Voltage Regulator Thermal Management

Part/System:	Dyna-70 Ultimate Upgrade Circuit Card Assembly (Auto. & Man. Bias
	configuration)
Effectivity:	3 April 2023
Priority:	Optional; an upgrade to the Dyna-70 is not required

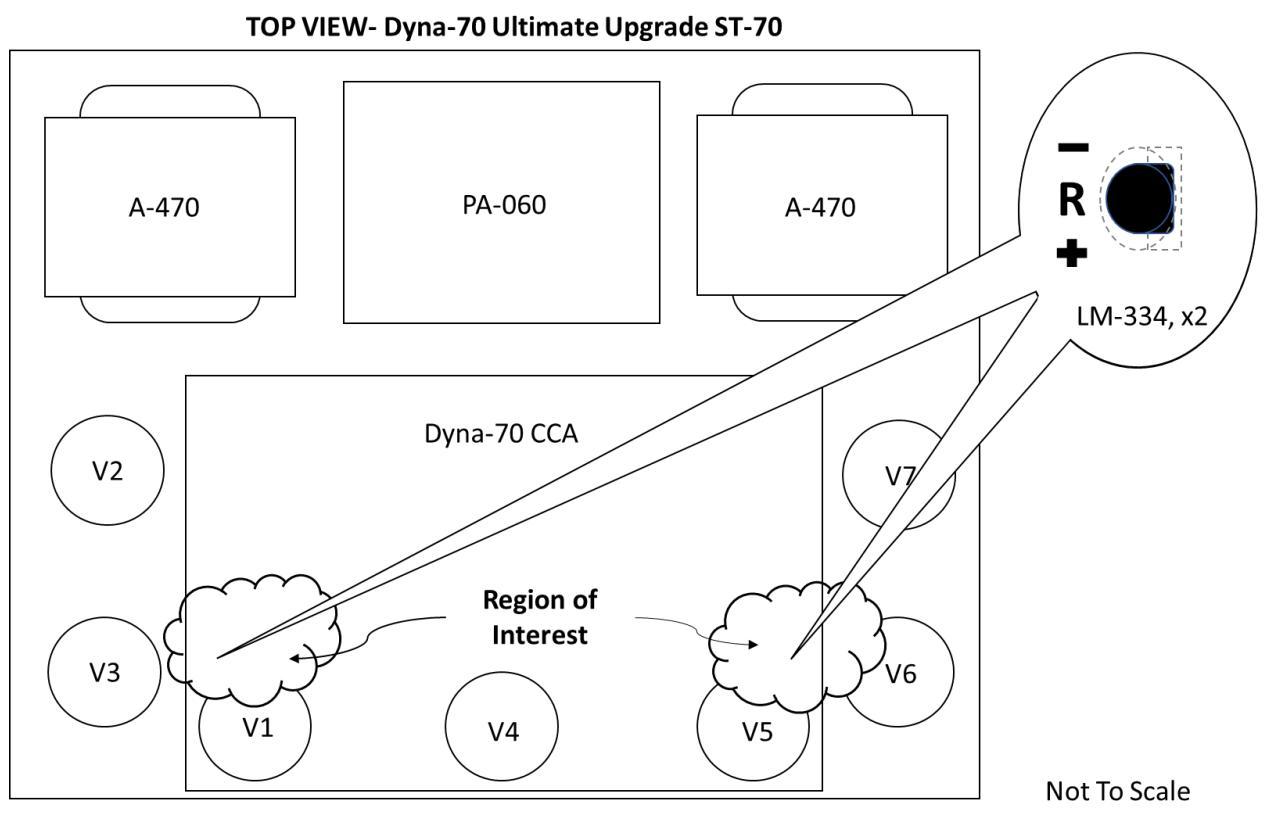
Figure 1- Thermal Region of Interest with LM-334 Regulator

Recent testing has demonstrated the LM-334 (i.e., all components in the LM134/234/334 family) exhibit thermal sensitivity (common with semiconductors) that can impart negative effects to the audio signal in the drive circuits in the 6SN7's for the left channel (V1) and right channel (V5).

The Dyna-70 Ultimate Upgrade utilizes two LM-334 voltage regulators for the amplifier drive stage of the left and right channel 6SN7 tubes, V1 and V5. Adjacent to the V1 and V5 6SN7 signal tubes, are V3 and V6, the left and right EL34/6CA7 power output tubes. The LM-334 is in this corner between tubes V1 & V3 on the left side and V5 and V6 on the right side, reference Figure 1.

MALLC investigated use of TO-92 style packages using heat sinks, however it was apparent that use of a heat sink in the Region of Interest only contributed to heating of the LM-334, where it reaches thermal equilibrium faster, not slower, inducing thermal distortion from the -334 sooner rather than later.
